# LIMITED ASBESTOS AND LEAD-CONTAINING PAINT SURVEY REPORT

## IERBYS BUILDING BURMA ROAD ALAMEDA COUNTY, CALIFORNIA

GEOCON PROJECT NO. E8560-06-46  
CALTRANS EA 04-0120F3  
CALTRANS PROJECT NO. 04-0000-0018-3

DECEMBER 2012

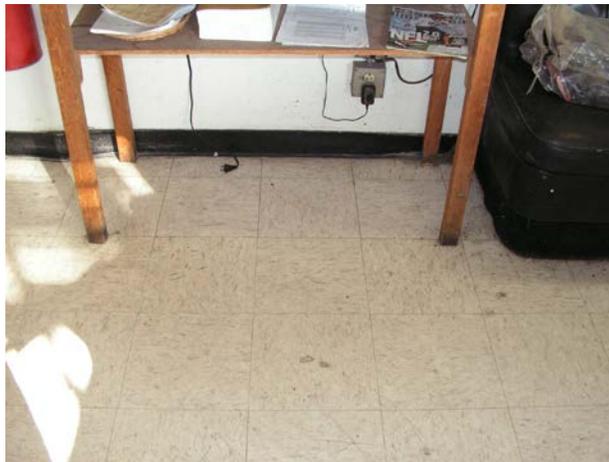
- Chrysotile asbestos at concentrations of 2% and 5-7% was detected in samples representing approximately 1,300 square feet nonfriable white with gray streaks 12-inch by 12-inch resilient floor tile and black mastic, respectively, in the conference room and offices.

**Photo 2 – Asbestos-containing white with gray streaks 12-inch by 12-inch resilient floor tiles and mastic in the conference room and offices**

However, the disturbance of these materials is still covered by the Cal/OSHA asbestos standard contained in Title 8, CCR Section 1529. We recommend that a licensed contractor registered with Cal/OSHA for asbestos-related work perform activities that would disturb the sheet packing. Contractors are responsible for informing landfills and recycling facilities of the contractor's intent to dispose of asbestos-containing waste. Some landfills and recycling facilities may require additional

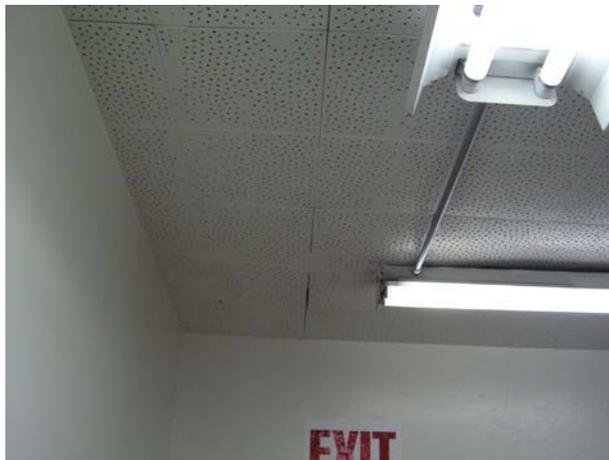
**Photo 3 – Acoustical ceiling tiles in the east office area and women’s restroom**

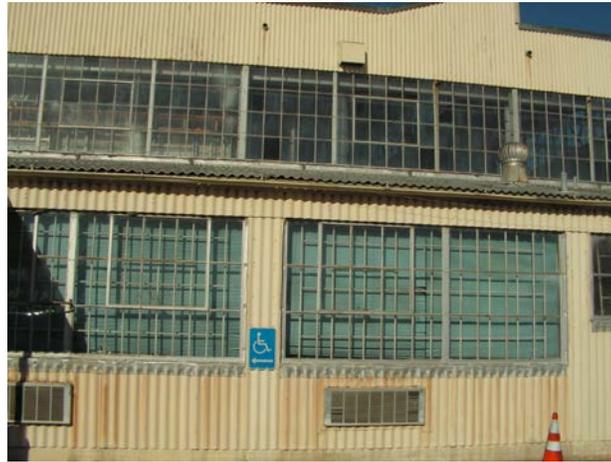
- Chrysotile asbestos at a concentration of less than (<) 0.25% by PLM point count analysis (400 points) was detected in samples representing approximately 1,400 square feet nonfriable window putty on the exterior windows.

**Photo 4 – Asbestos-containing window putty on the lower windows**

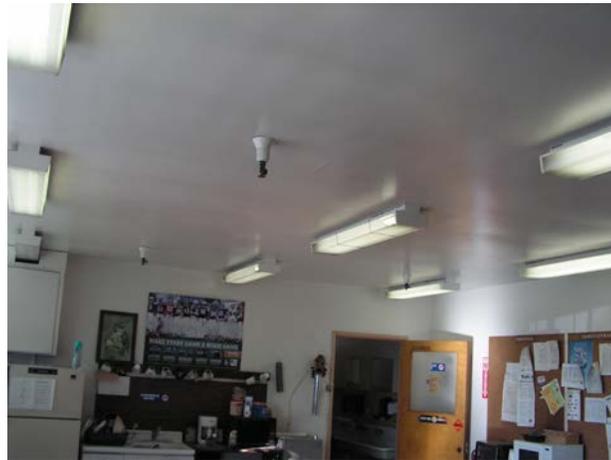
- Chrysotile asbestos at concentrations of <1 – 2% was detected in samples representing joint compound applied to approximately 9,100 square feet of gypsum board wall system in the offices and restrooms. Point count analysis (400 points) of the gypsum board/joint compound composite samples indicated chrysotile asbestos at a concentration of <0.25%. Chrysotile asbestos at concentrations of <0.25 – 1.00% by PLM point count analysis (400 points) was detected in samples of wall texture applied to the gypsum board wall system.

**Photo 5 – Gypsum board wall system (asbestos-containing joint compound and wall texture) and interior paint in the conference room and offices**

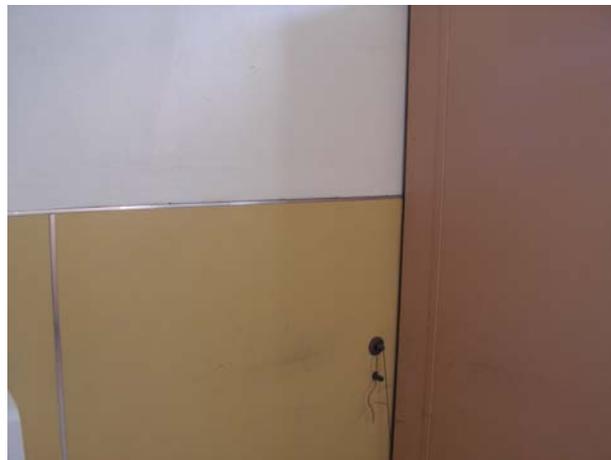
**Photo 6 – Wall panel adhesive and gypsum board wall system (asbestos-containing joint compound and wall texture) in the men's restroom and locker room**

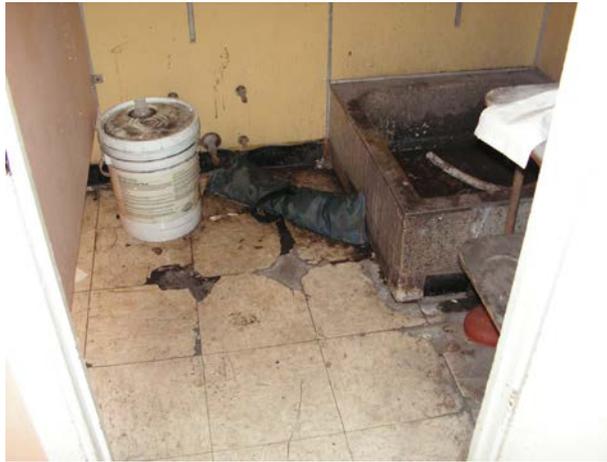
- Chrysotile asbestos at concentrations of <1% and 6-7% was detected in samples representing approximately 550 square feet nonfriable off-white with brown streaks 12-inch by 12-inch resilient floor tile and black mastic, respectively, in the men's restroom and locker room.

**Photo 7 – Asbestos-containing off-white with brown streaks 12-inch by 12-inch resilient floor tile with black mastic in the men’s restroom and locker room**

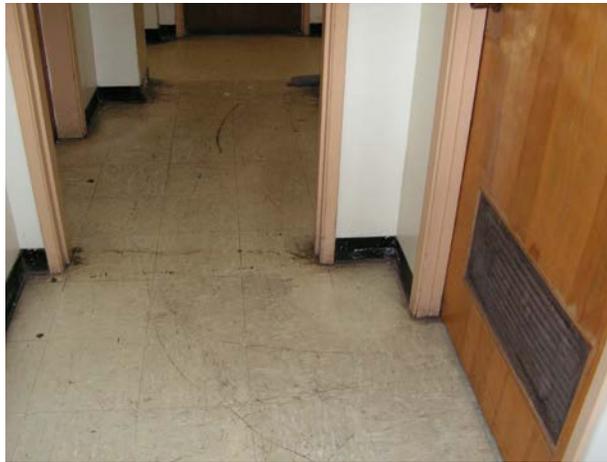
- Chrysotile asbestos at a concentration of <1% was detected in samples representing approximately 100 square feet nonfriable white with olive streaks 12-inch by 12-inch resilient floor tile in the storage area entry hall.

**Photo 8 – Asbestos-containing white with olive streaks 12-inch by 12-inch resilient floor tile in the storage area entry hall**

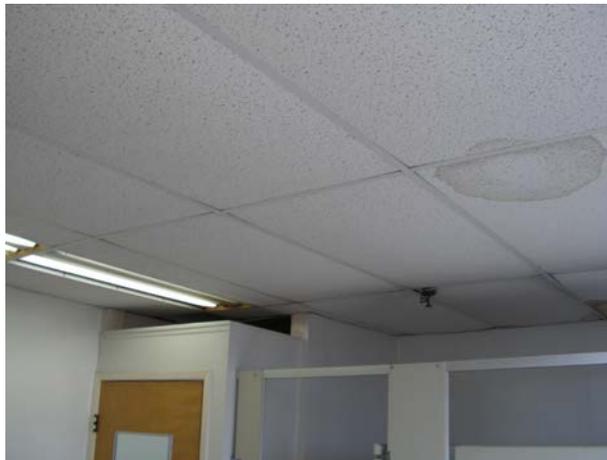
**Photo 9 – White 2-foot by 4-foot acoustic ceiling panels in the women’s restroom**

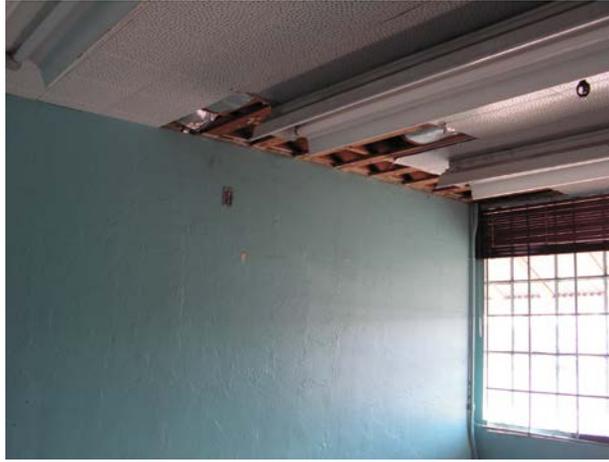
**Photo 10 – Gypsum board wall system (asbestos-containing joint compound and wall texture) in the east office and women’s restroom**

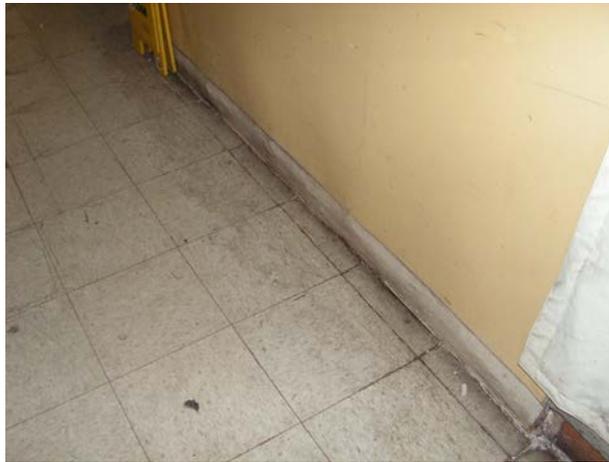
- Chrysotile asbestos at a concentration of <1% was detected in samples representing approximately 1,100 square feet nonfriable olive resilient floor tile (lower layer of multi layered flooring) in the east office and women's restroom.

**Photo 11 – Off-white with brown streaks 12-inch by 12-inch resilient floor tile over asbestos-containing olive floor tile (multi-layered flooring) in the east office and women’s restroom**

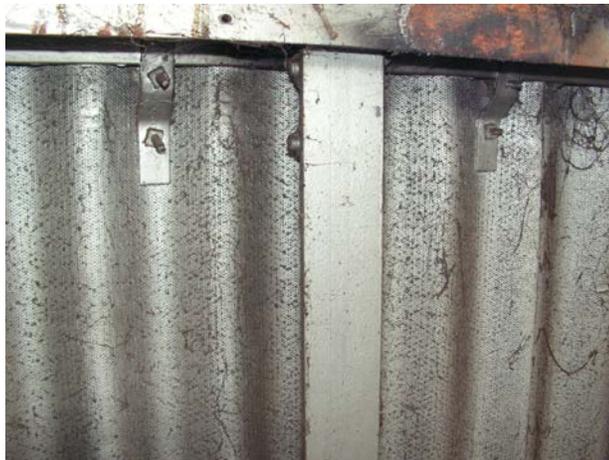
Intact silver interior paint and tan exterior paint identified during our LCP survey would be classified as a California hazardous waste and Federal (RCRA) waste based on lead content if stripped, blasted, or otherwise separated from the substrate.

**Photo 12 – Interior silver paint (warehouse areas)**

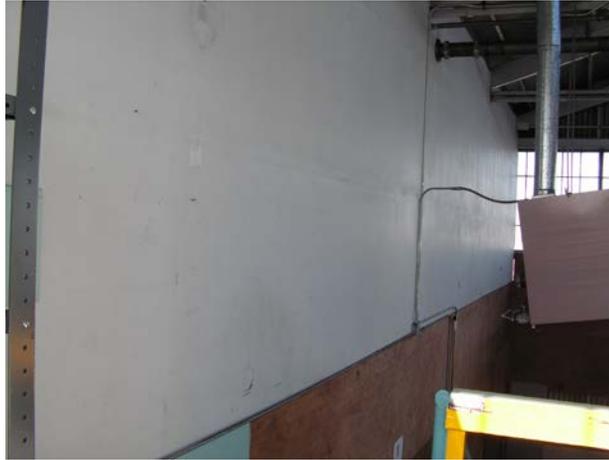
- Chrysotile asbestos at concentrations of <1 – 2% was detected in samples representing joint compound applied to approximately 7,500 square feet of gypsum board wall system (dividing walls) in the warehouse portion of the building. Point count analysis (400 points) of the gypsum board/joint compound composite samples indicated chrysotile asbestos at a concentration of <0.25%. Chrysotile asbestos at concentrations of 0.25 – 0.50% by PLM point count analysis (400 points) was detected in samples of wall texture applied to the gypsum board wall system.

**Photo 13 – Gypsum board wall system (asbestos-containing joint compound and wall texture) in the warehouse areas**

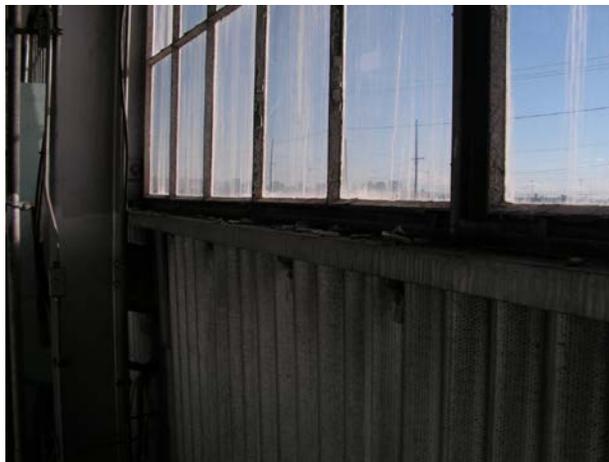
**Photo 14 – Asbestos-containing window putty on the warehouse area windows**

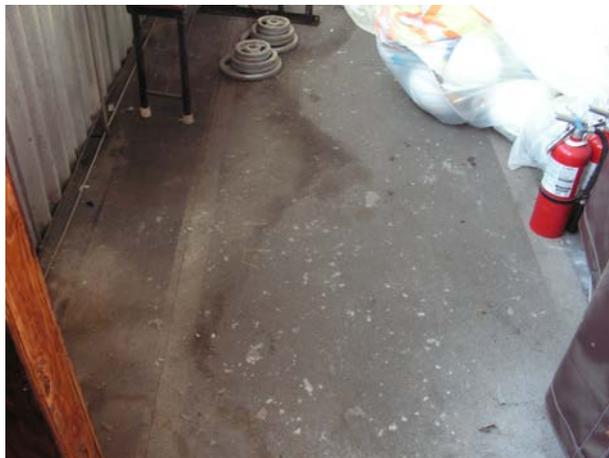
**Photo 15 – Black non-skid coating on the Steel Erection Shop mezzanine floor**

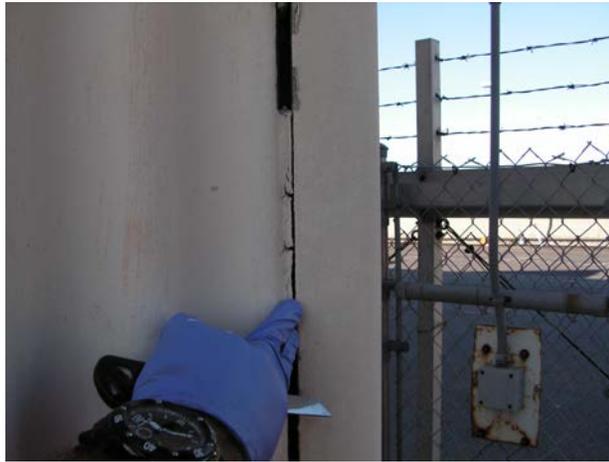
- Chrysotile asbestos at a concentration of 2% was detected in samples representing approximately 75 square feet nonfriable wall panel and penetration sealant applied to corner joints and wall penetrations of the exterior cementitious wall panels.

**Photo 16 – Asbestos-containing cementitious panel sealant on the exterior walls**

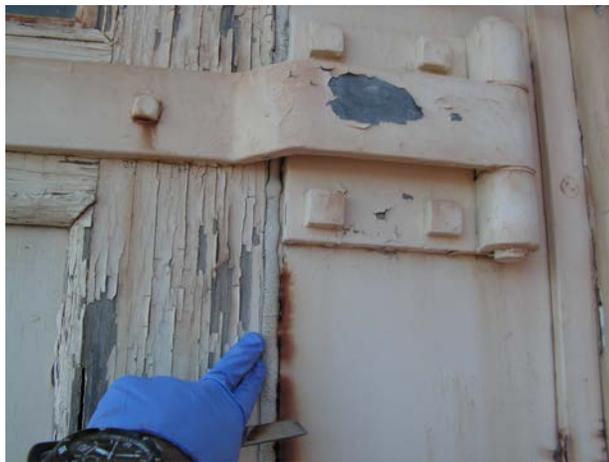
**Photo 17 – White door frame sealant on the storage area east wooden doors**

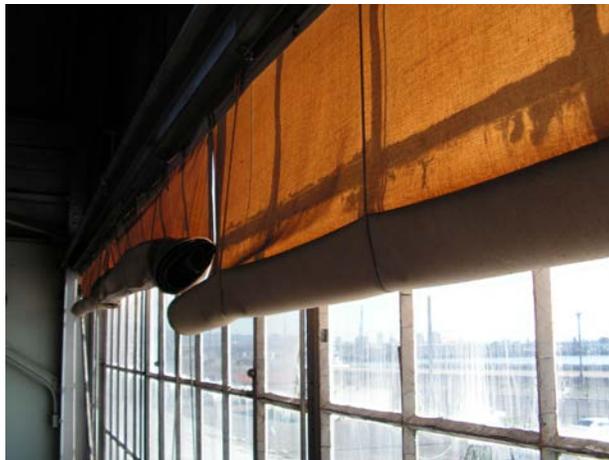
**Photo 18 – Canvas curtains in the Carpentry Shop**

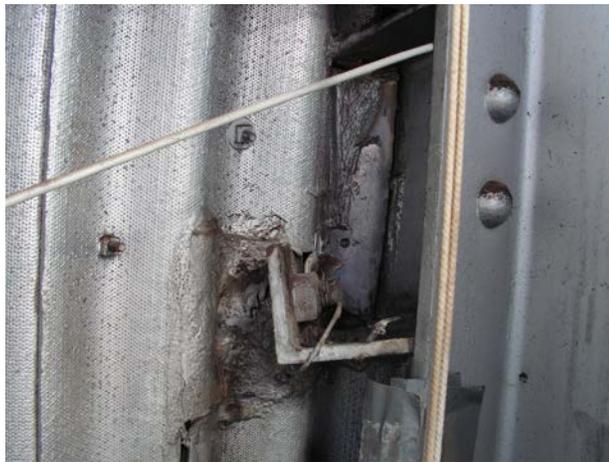
**Photo 19 – Asbestos-containing cementitious panel sealant on the interior walls**

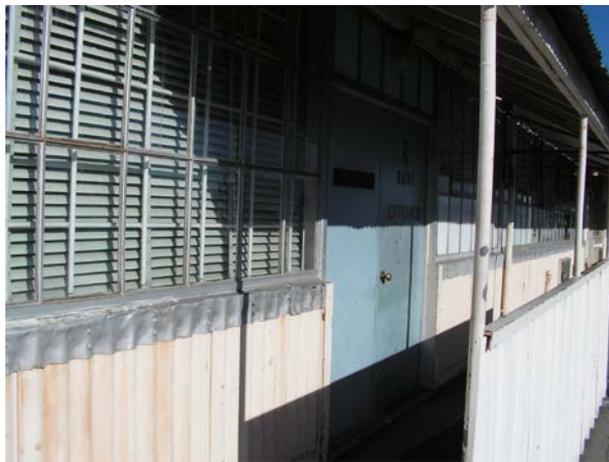
**Photo 20 – Fire door at the conference room entrance**

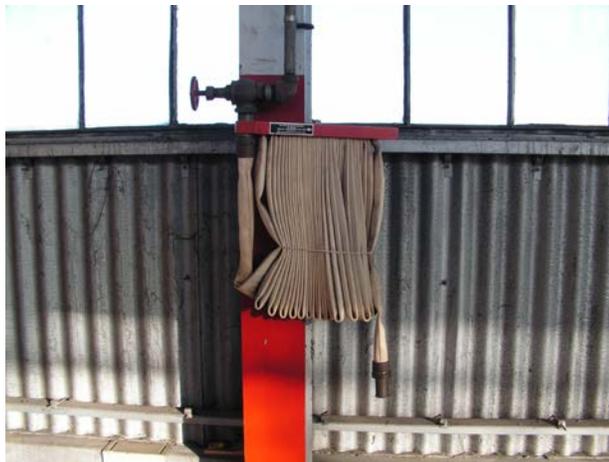
**Photo 21 – Fire hose in the warehouse areas**
