Technical Memorandum

Subject: Additional Soil Characterization for Richmond San Rafael Bridge Bike Path Project: Sir Francis Drake Blvd EB-580 On-Ramp Area

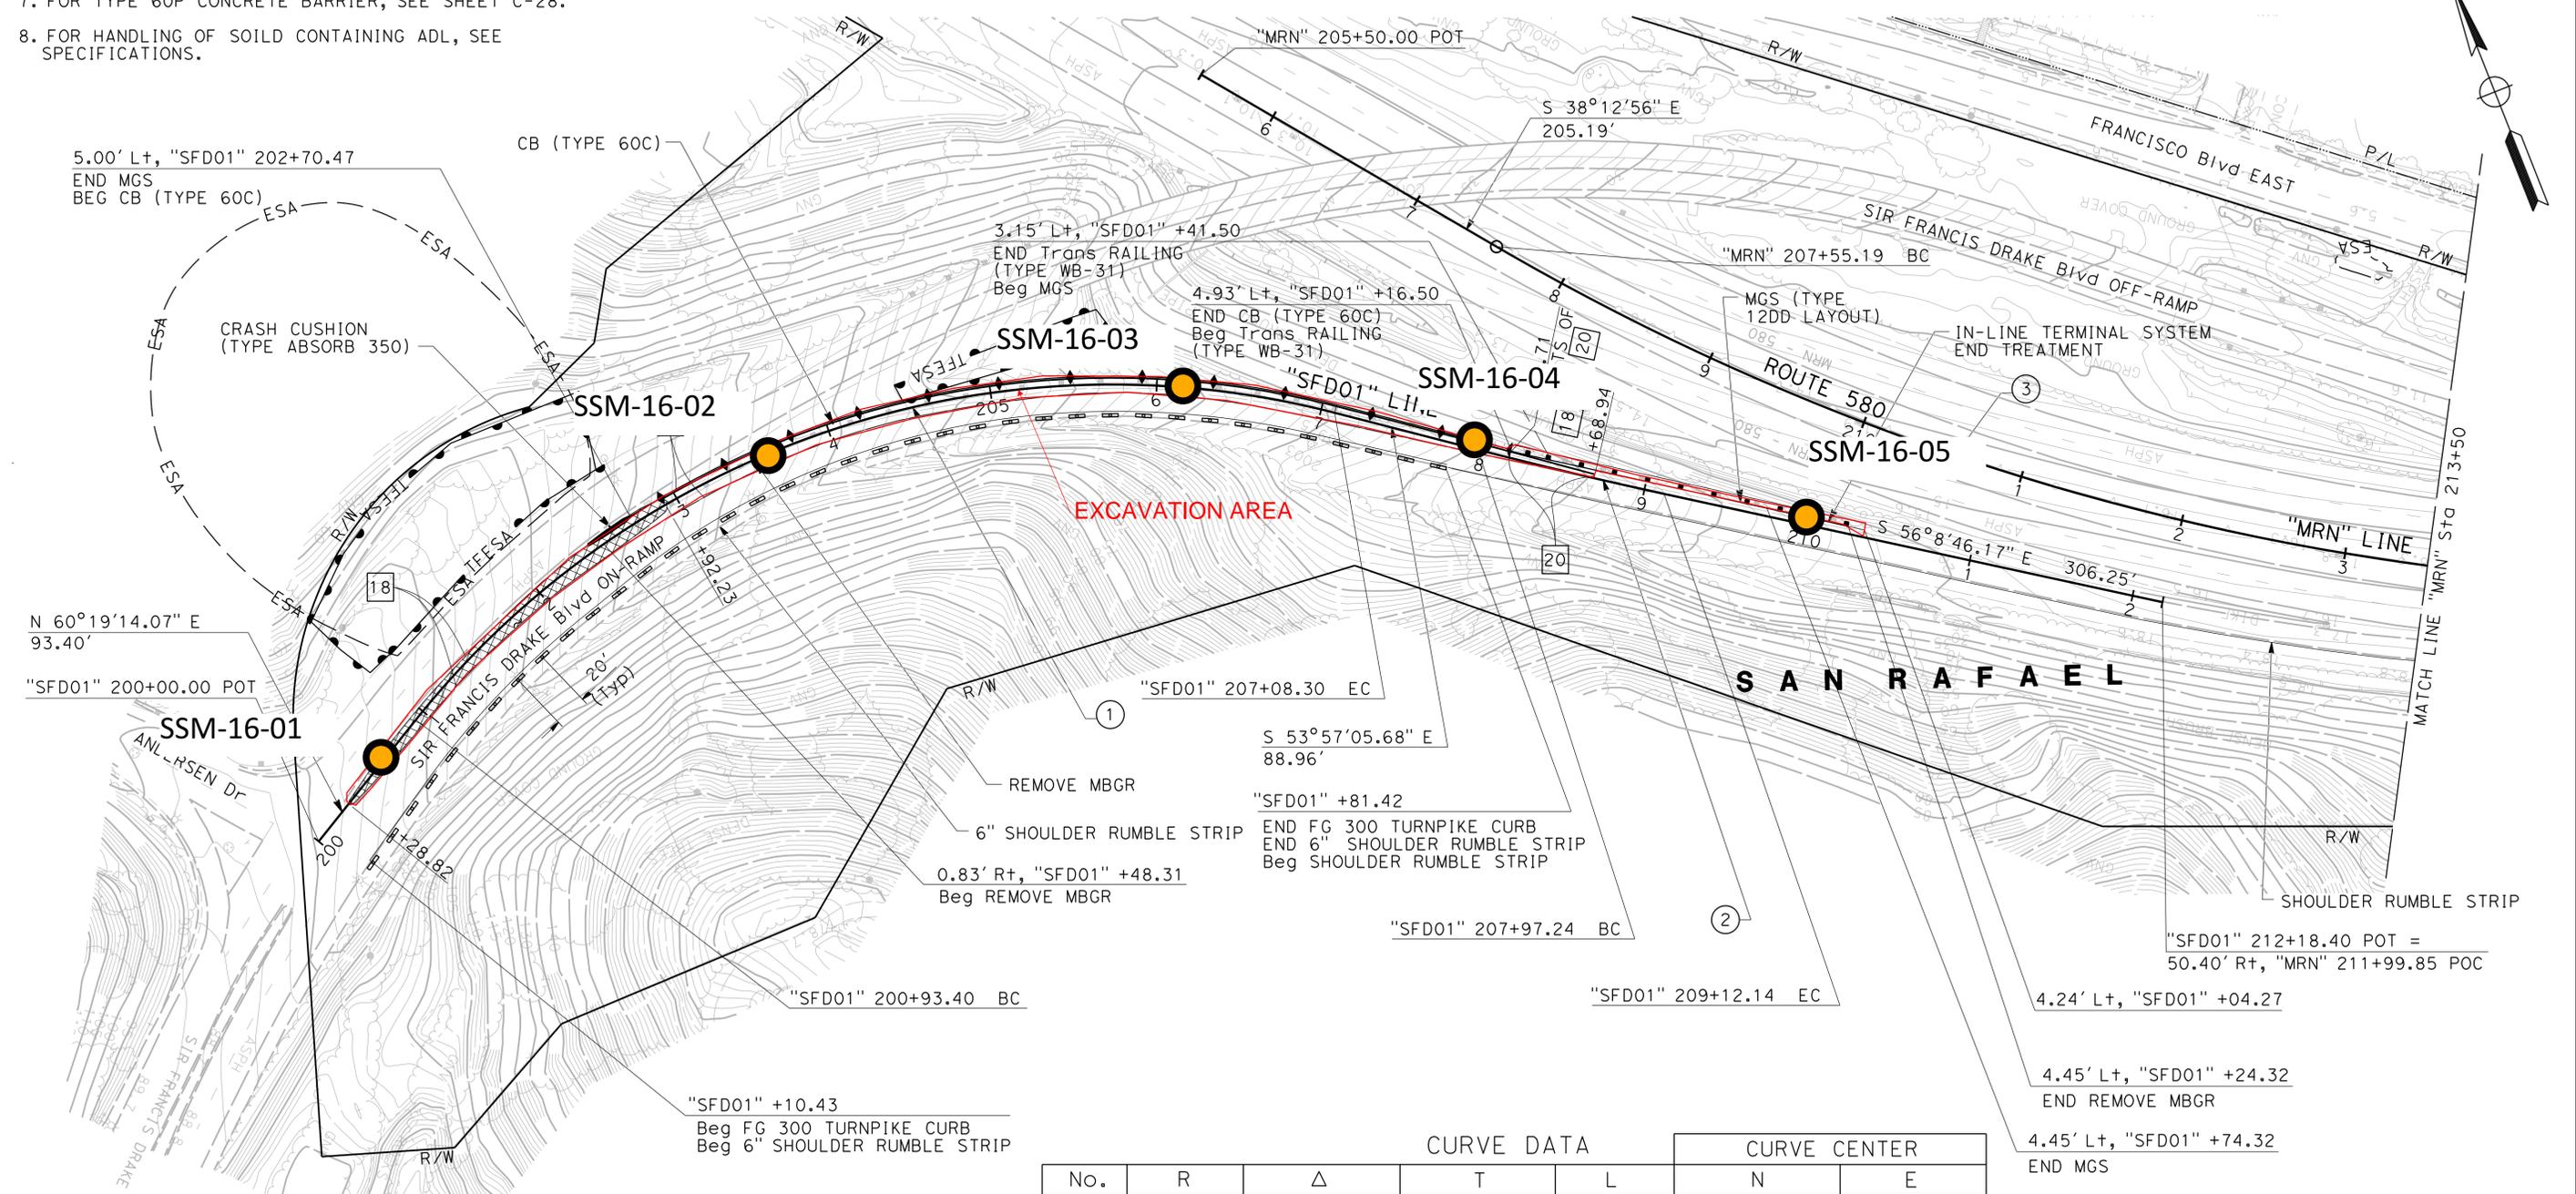
LAYOUT
SCALE: 1" = 50'
L-1

On August 15, 5 soil borings were advanced using a hollow-stem auger at the locations shown in the enclosed Figure. Shallow and deep soil samples were collected from each boring using a slide hammer with clean brass sleeves. The two samples per boring were combined into one pre-labeled glass jar and stored in a chilled cooler, on ice and transported under chain-of-custody protocol to Curtis & Tompkins Laboratory in Berkeley, Ca.

APPROXIMATE SOIL SAMPLE LOCATIONS - ●

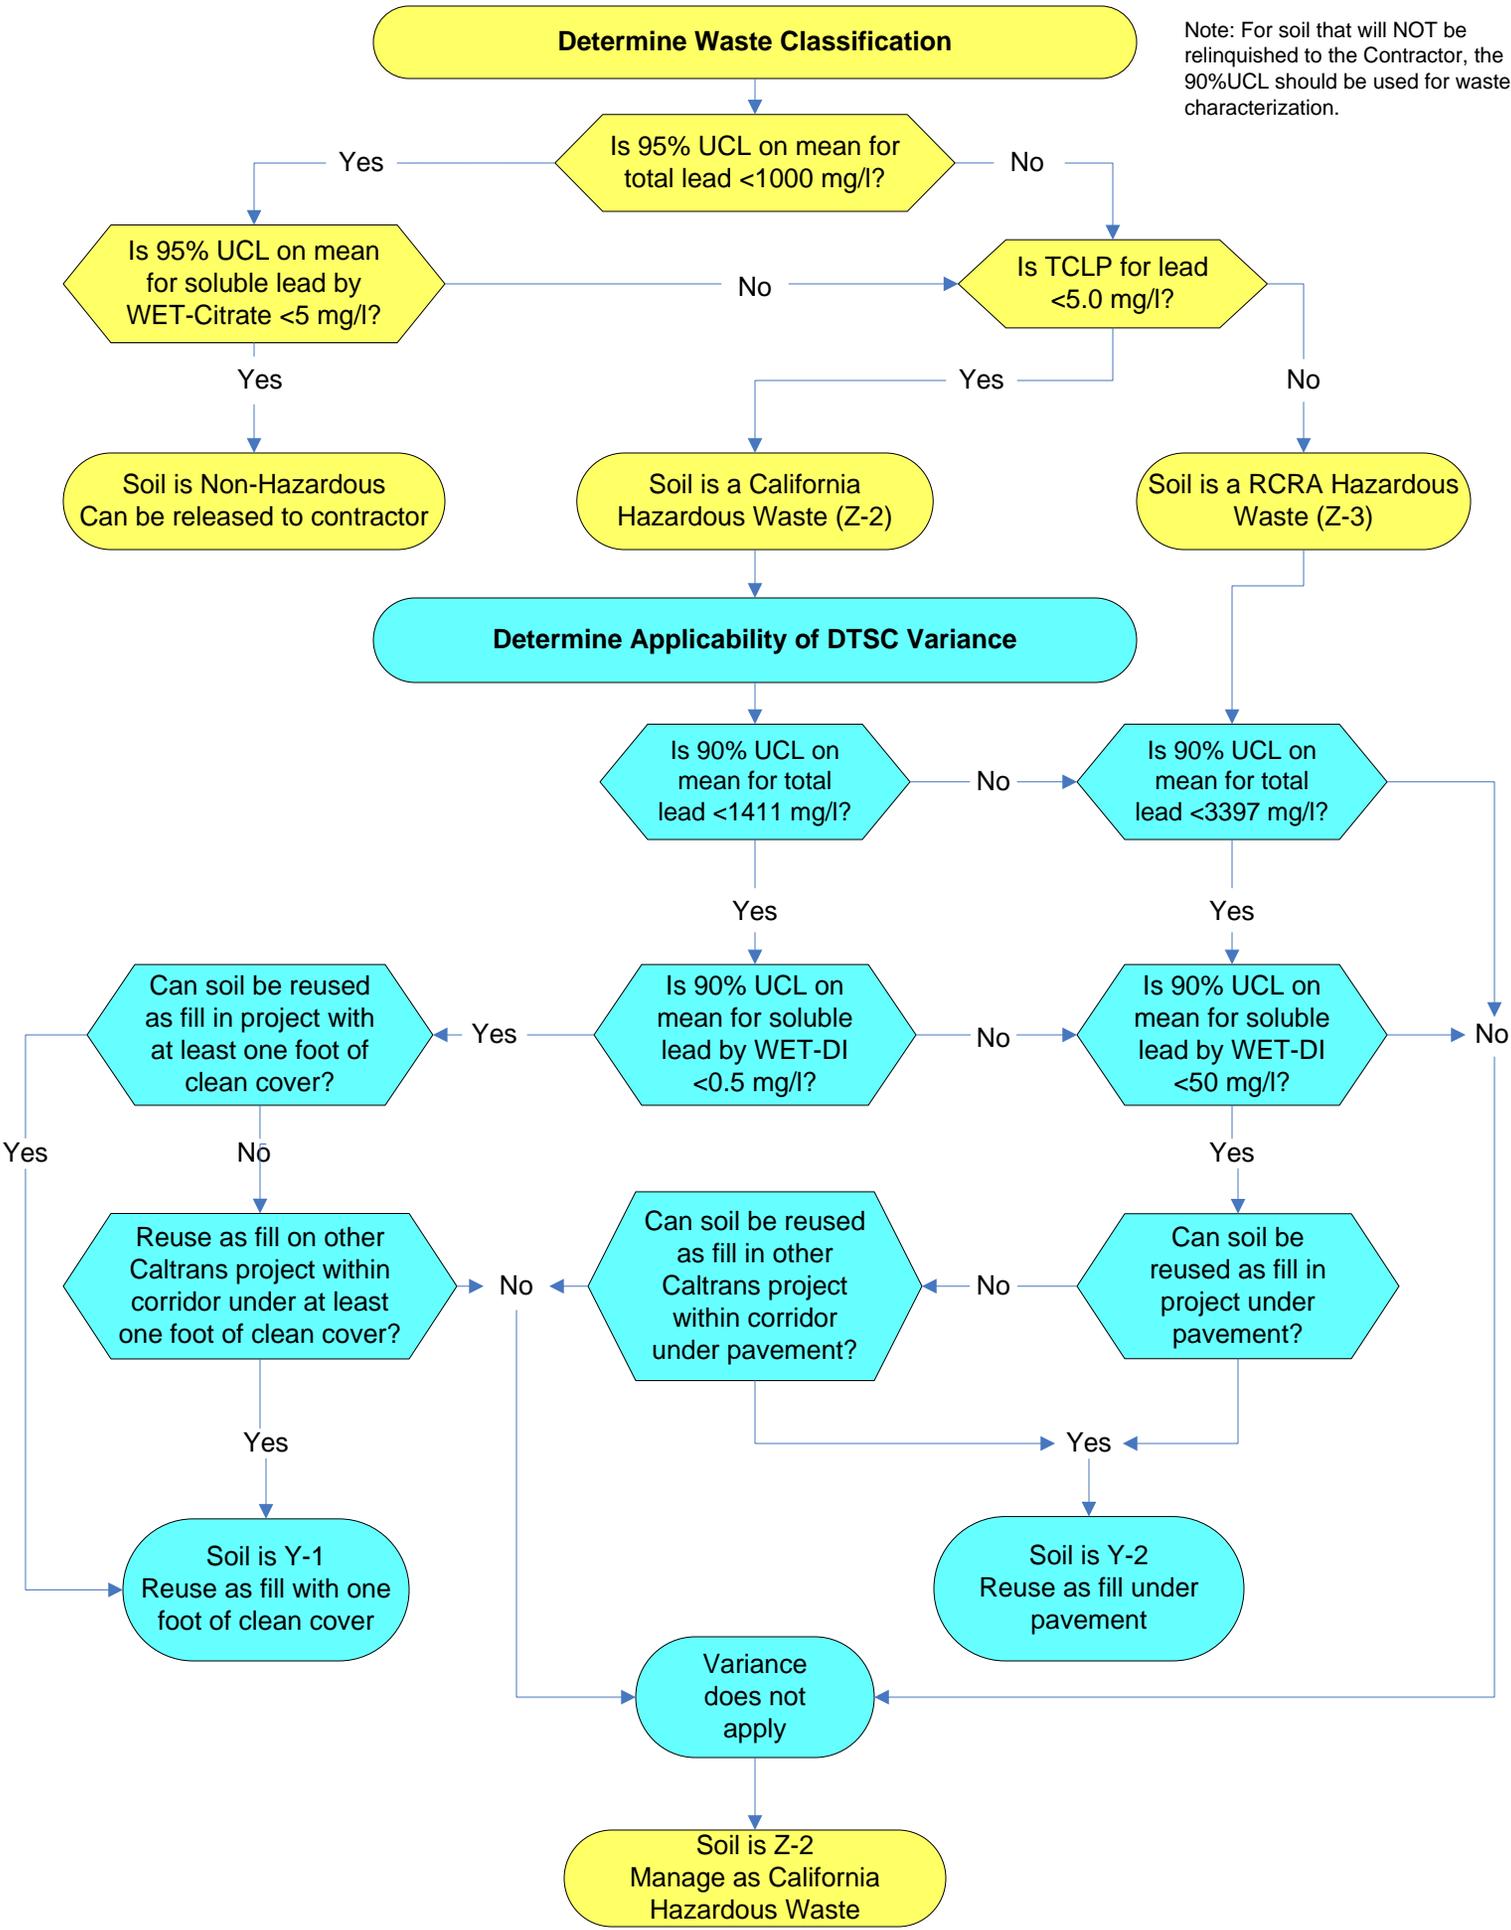
Figure 1: ADL-Impacted Soils Management Flow Chart

ADL-IMPACTED SOILS MANAGEMENT FLOW CHART

Note: For soil that will NOT be relinquished to the Contractor, the 90%UCL should be used for waste characterization.

Analytical results are presented in Table 1 (below) and laboratory analytical reports are included in Attachment A. In accordance with CalTrans ADL-Impacted Soils Management Flow Chart (Attachment B), 95% Upper Confidence Limit (UCL) analysis was calculated for each data set. The results (tabulated below) were compared to the flow chart. The 95% UCL on mean for total lead was less than 1,000 mg/kg and the 95% UCL on mean for soluble lead by WET Citrate was less than 5 mg/L.

The 95% UCL on mean for total lead and WET-Citrate lead are 93.4 mg/kg and 3.4 mg/L, respectively. Therefore, in accordance with the CalTrans ADL-Impacted Soils Management Flow Chart, the soil is non-hazardous and can be released to the contractor for re-use. No DTSC variance is needed.
