# LIMITED ASBESTOS AND LEAD-CONTAINING PAINT SURVEY REPORT

## IERBYS BUILDING BURMA ROAD ALAMEDA COUNTY, CALIFORNIA

GEOCON PROJECT NO. E8560-06-46  
CALTRANS EA 04-0120F3  
CALTRANS PROJECT NO. 04-0000-0018-3

DECEMBER 2012

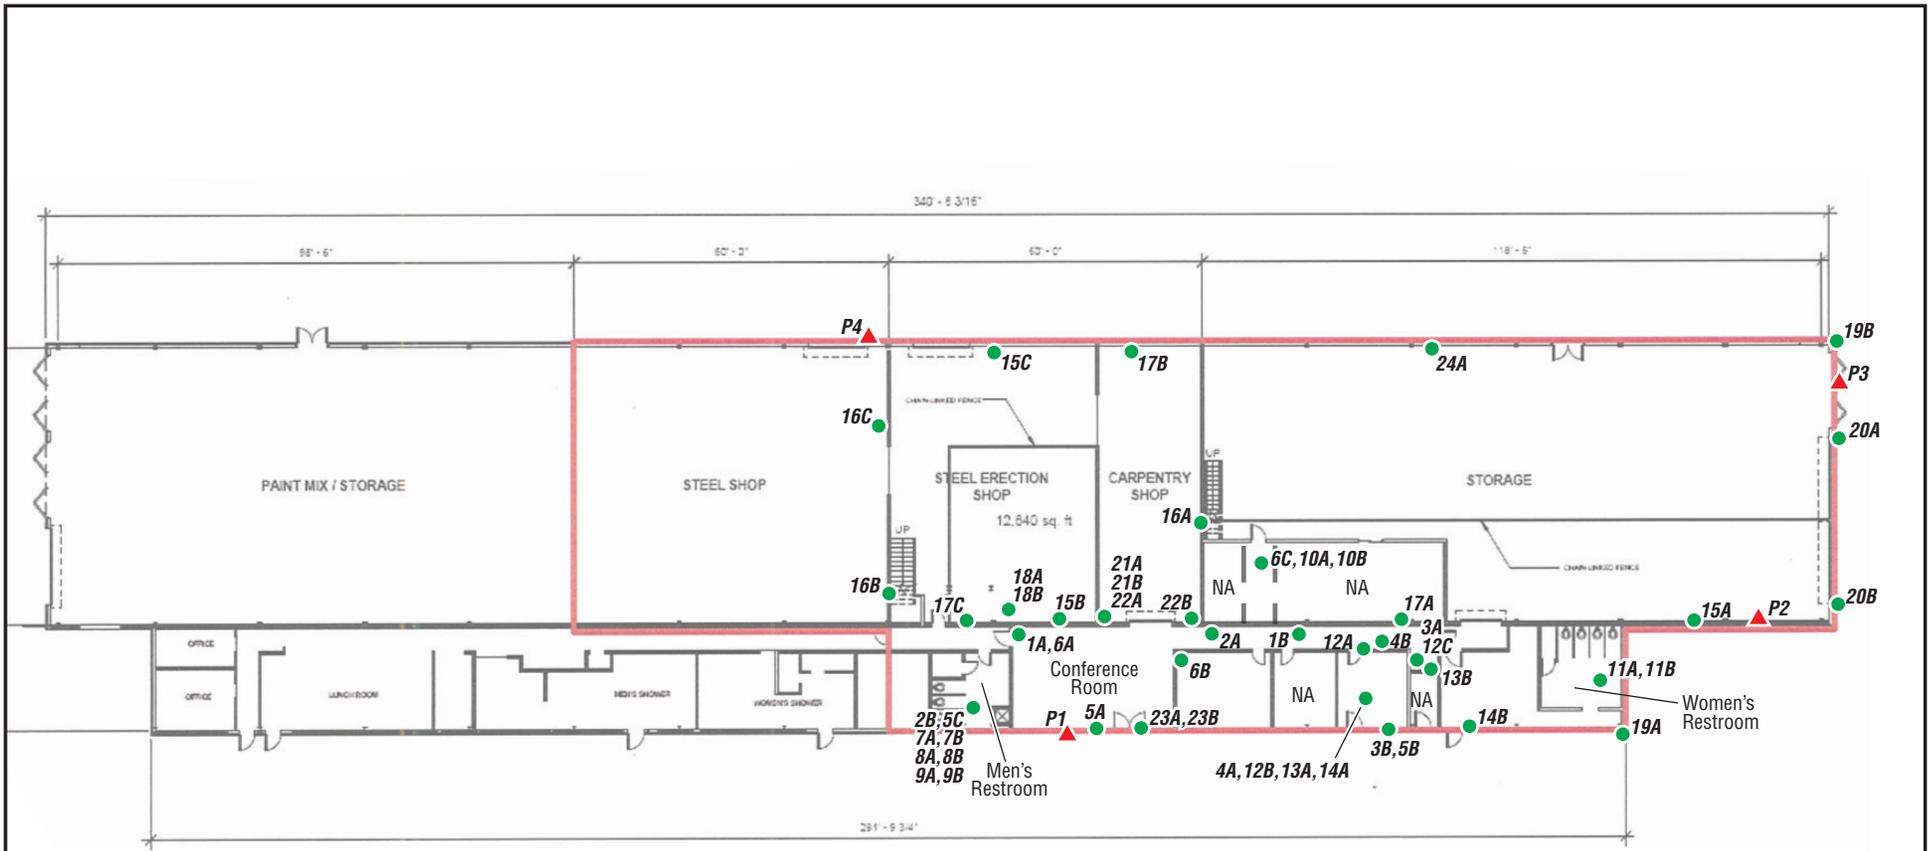
<b>GEOCON</b> CONSULTANTS, INC. <small>6671 BRISA STREET - LIVERMORE, CA 94550          PHONE 925.371.5900 - FAX 925.371.5915</small>	
IERBYS Building Burma Road	
Alameda County, California	<b>SITE PLAN</b>
GEOCON Proj. No. E8560-06-46	
Task Order No. 46	December 2012    Figure 2

Samples were collected from locations as shown on the Site Plan (Figure 2). Suspect asbestos and LCP sample identification numbers are presented in Tables 1 and 2, respectively. Materials represented by the samples collected are presented in the Site Photographs.

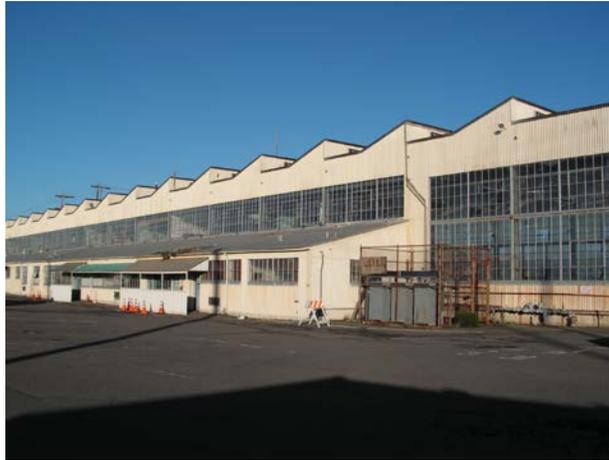
**Photo 1 – IERBYS Building, Burma Road in Alameda County, California**
